THOMAS MORAN'S OUTBUILDINGS AT *THE STUDIO*

229 MAIN STREET, EAST HAMPTON, N.Y.

HISTORIC STRUCTURE REPORT

April 2010

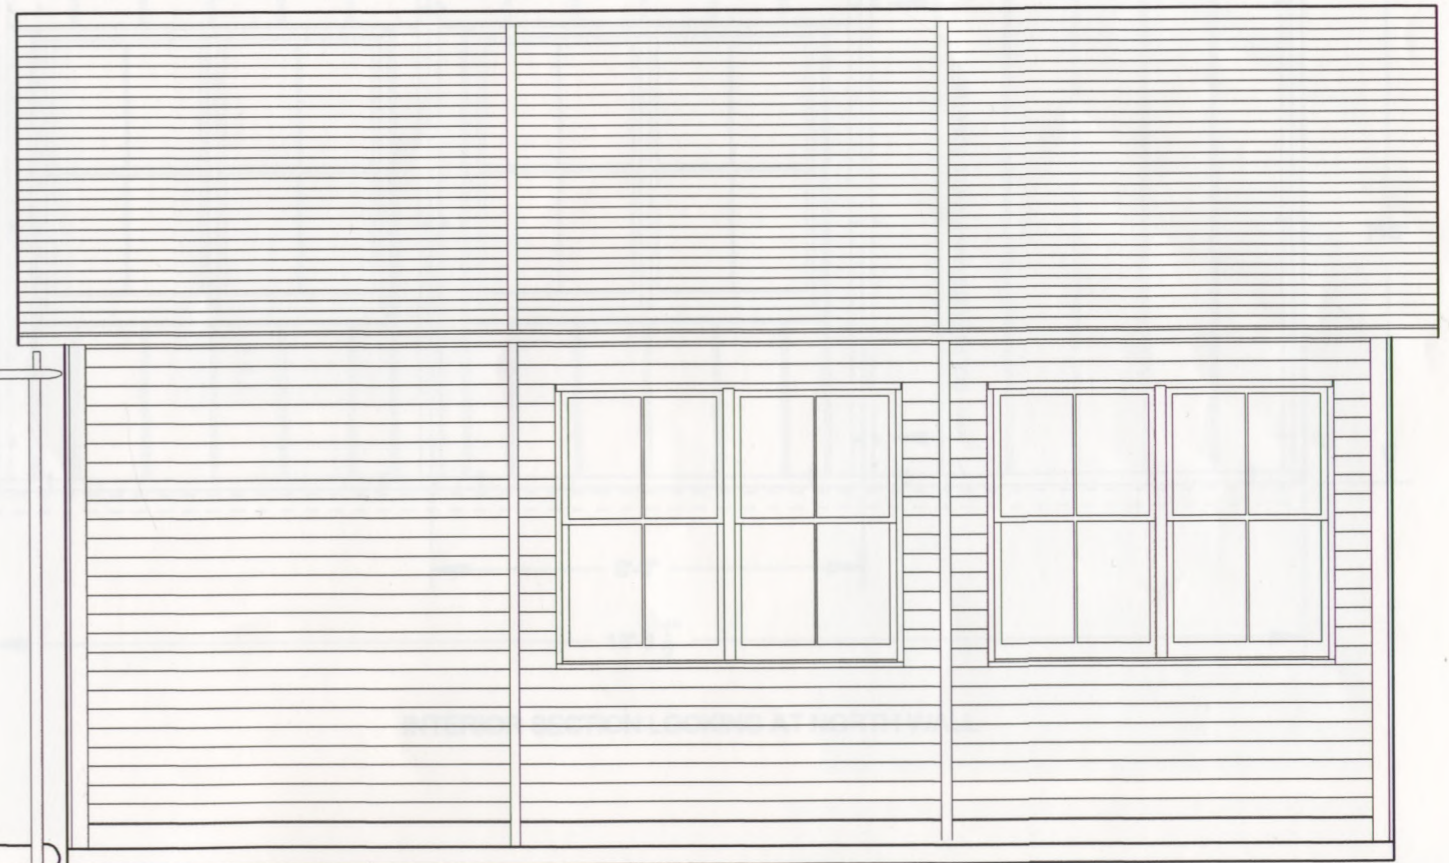
NORTH WALL RESTORED

CONJECTURAL
REPRESENTATION OF
ORIGINAL PERGOLA
AT ENTRANCE

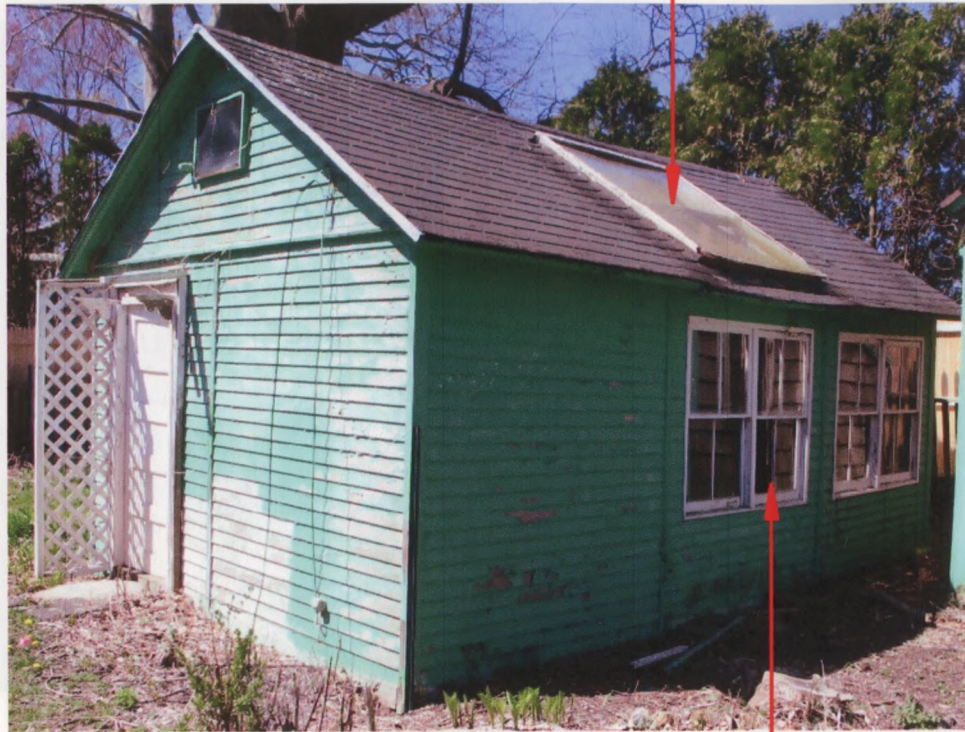
ORIGINAL DOUBLE WINDOWS DESCRIBED IN THE HODGSON CATALOG AS "SUNROOM WINDOWS."

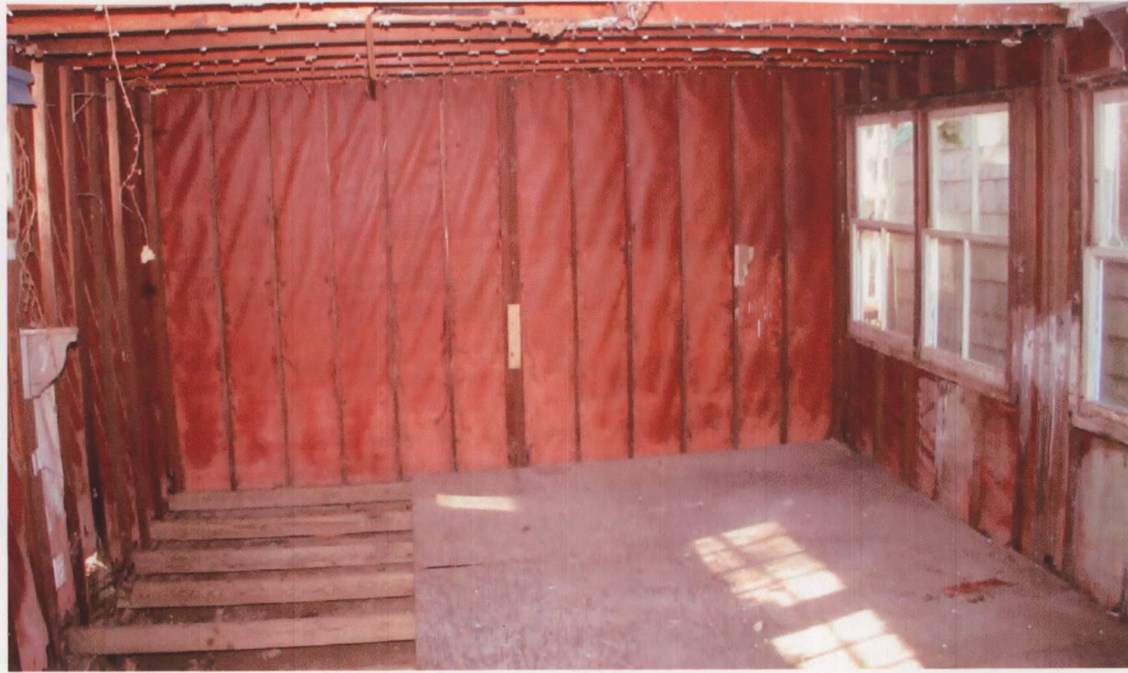
INTERIOR VIEW LOOKING TOWARD THE WEST WALL SHOWING THE PANEL FRAMING, WIGWARM PAPER LINING AND "SUNROOM WINDOWS" IN THE NORTH WALL. THE CEILING JOISTS WERE INSTALLED IN THE 1950S AND THE FLOOR JOISTS AND PLYWOOD FLOORING LATER.

Condie Lamb made some alterations to the Hodgson Cottage when he refurbished it for use as his studio in the 1950s. These alterations included: installing a skylight in the north roof slope; placing a new window in the south wall; installing a ceiling of 2x4 joists and sheetrock; and constructing some built-in storage. At a later date the original floor frame and pine flooring was replaced with new joists and plywood flooring.

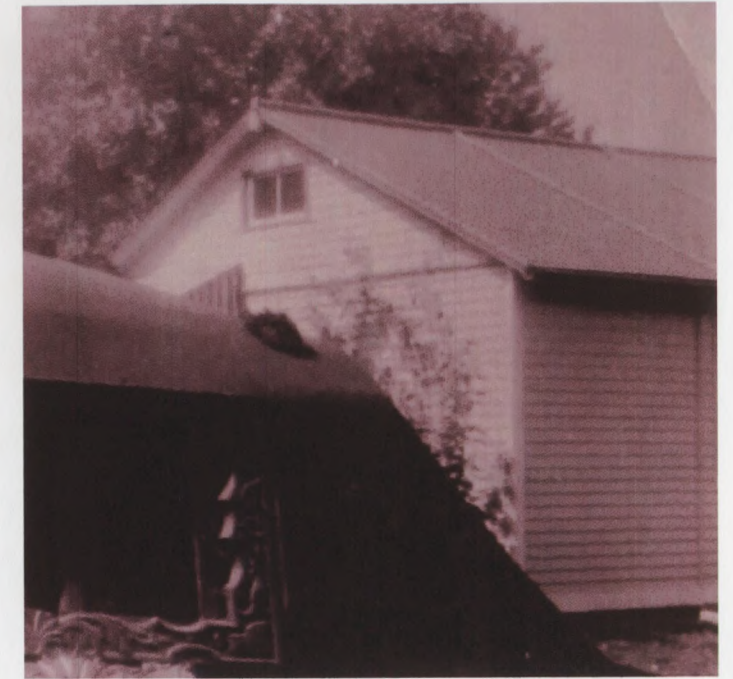
DETAIL OF UNDATED PHOTOGRAPH SHOWING THE GREEN CLAPBOARD ROOF PANELS, RIDGE ROLL AND STRIPED AWNING OVER THE DOOR.

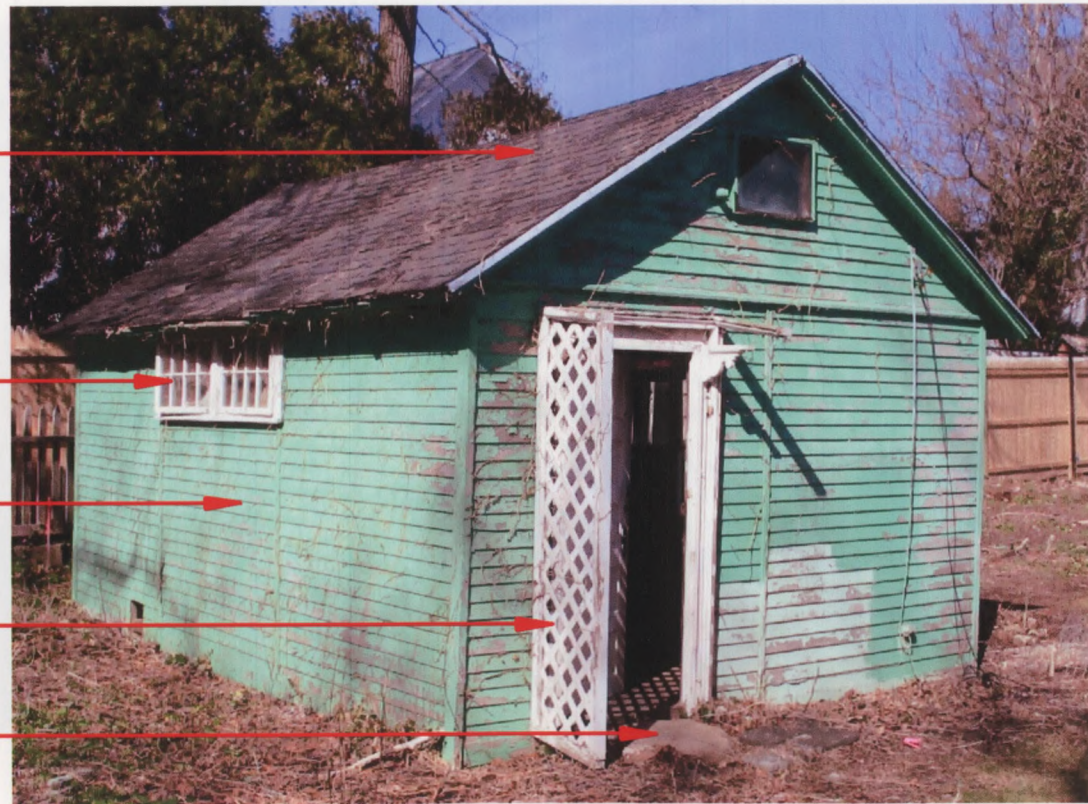
ASPHALT SHINGLES ARE OVER THE ORIGINAL CLAPBOARD ROOF PANELS

WINDOW INSTALLED IN THE 1950S

THREE ORIGINAL CLAPBOARD WALL PANELS, 6' WIDE, WITH BATTENS COVERING THE JOINTS

LATTICE AND BRACKETS INSTALLED IN THE 1950S

MORAN-ERA STONE STEP AT DOORWAY

- the plywood flooring and floor joists;
- the skylight in the north roof slope;
- the window in the south wall;
- the lattice and brackets at the entrance;
- the asphalt shingle roofing; and
- all 2x4 ceiling joists and studs from the interior.

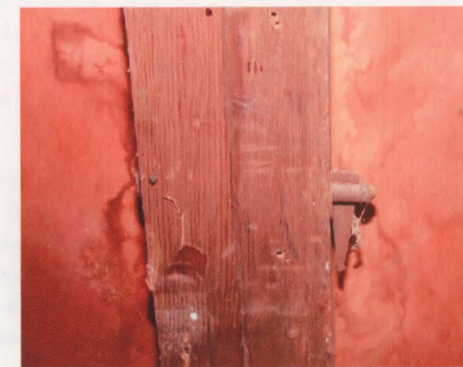
THE "WIGWARM KEY BOLT" FASTENING TWO WALL PANELS TOGETHER

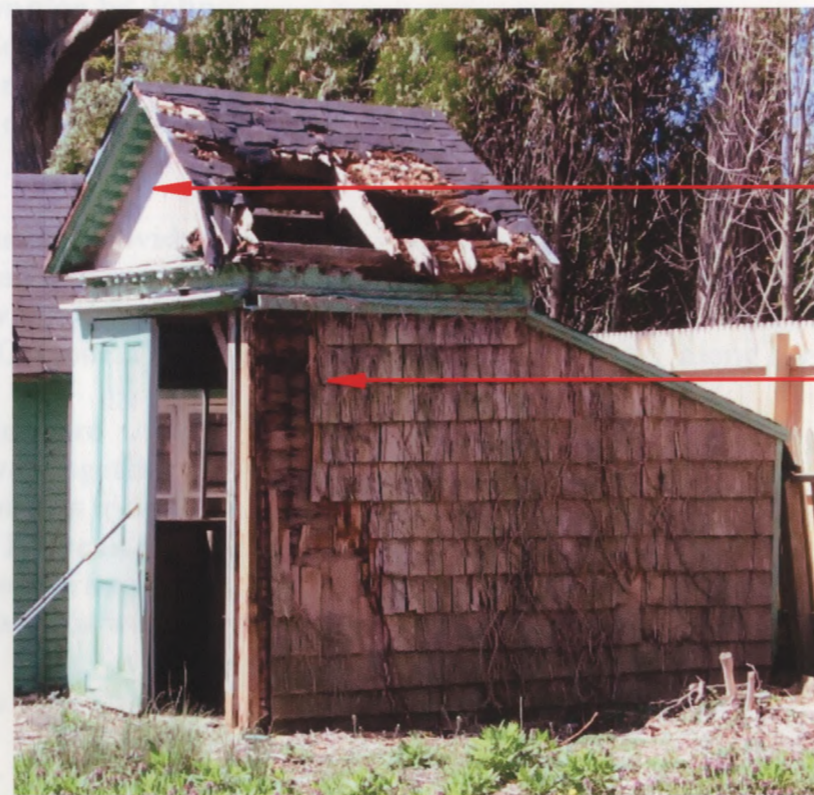
BOAT HOUSE, EAST AND NORTH WALLS

PEDIMENT OF 1884
FRONT PORCH

INTERIOR VIEW OF SIDE
LINTEL OF 1884 PORCH
PEDIMENT

ORIGINAL SHINGLES AND
SHEATHING OF A PORCH ROOF
RECYCLED AS A WALL UNDER
SIDE LINTEL OF PEDIMENT

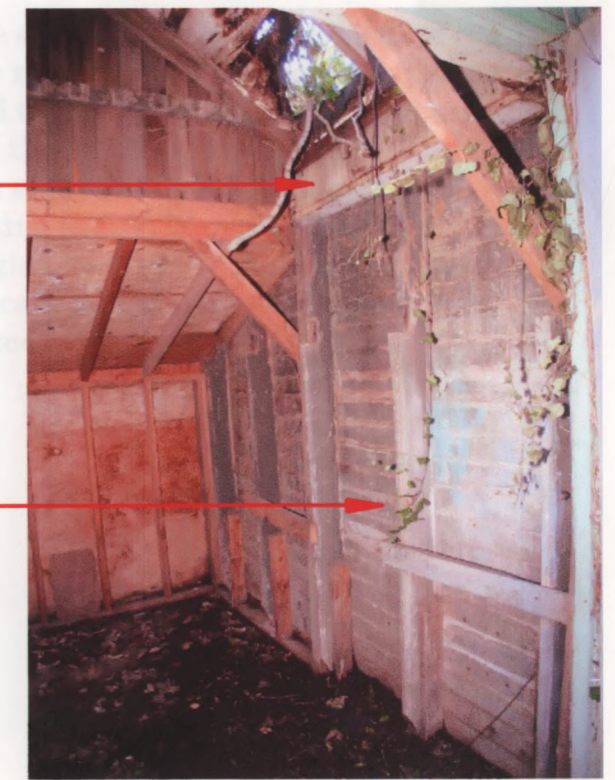
BOAT HOUSE, INTERIOR VIEW
OF WEST AND NORTH WALLS

INTERIOR VIEW OF THE NORTH
WALL SHOWING THE PORCH
ROOF RAFTERS NOW ACTING
AS WALL STUDS AND THE
BEADED ROOF SHEATHING ALL
WITH THE ORIGINAL
DARK GREEN PAINT

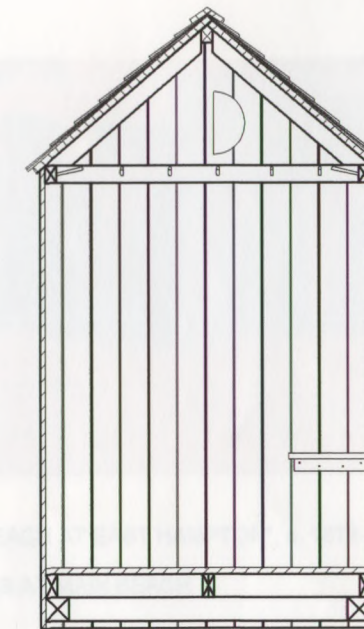
BUILDING SECTION LOOKING AT SOUTH INTERIOR WALL WITH BENCH RESTORED AND SHOWING PEGS FOR CLOTHING

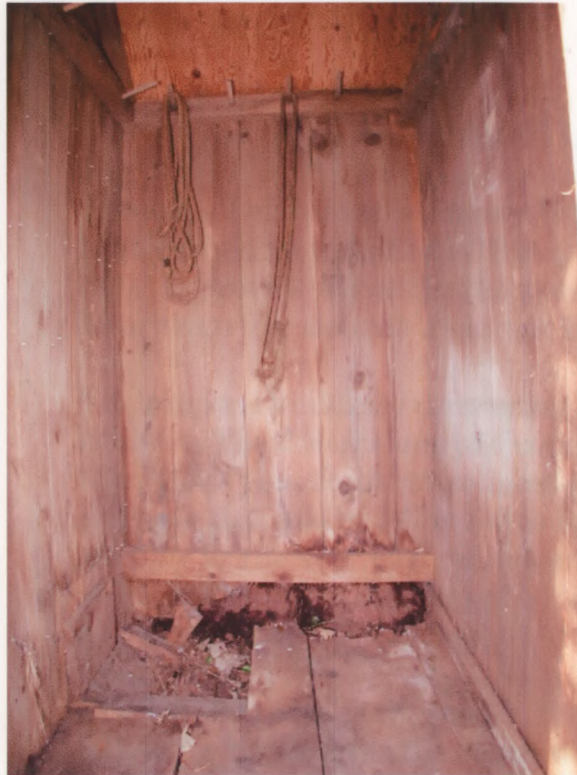
INTERIOR OF SMALLER SOUTH ROOM
SHOWING PEGS SET IN THE PLATE AND GABLE TIE

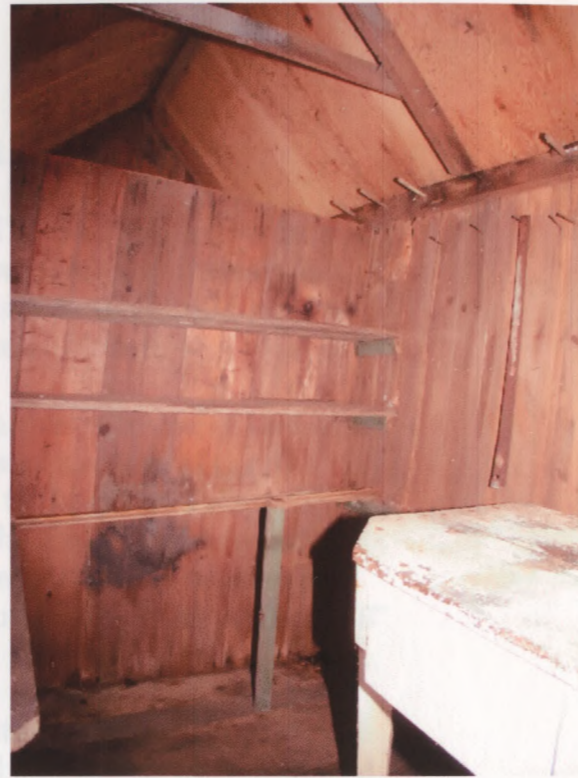
INTERIOR OF LARGER NORTH ROOM
LOOKING SOUTH TOWARD THE DIVIDING
PARTITION AND SHOWING THE PEGS SET IN THE PLATE

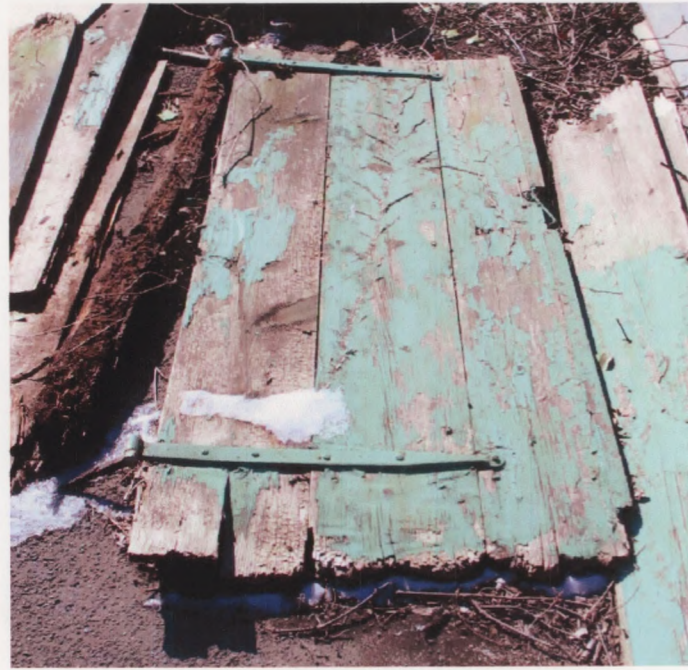
19TH-CENTURY DOOR FROM SOUTH WALL WITH ROTTED STUD ATTACHED

ORIGINAL OAK STUDS AND PINE SHEATHING

LOOKING THROUGH OPEN WALL TO STOCKADE FENCE ON PROPERTY LINE

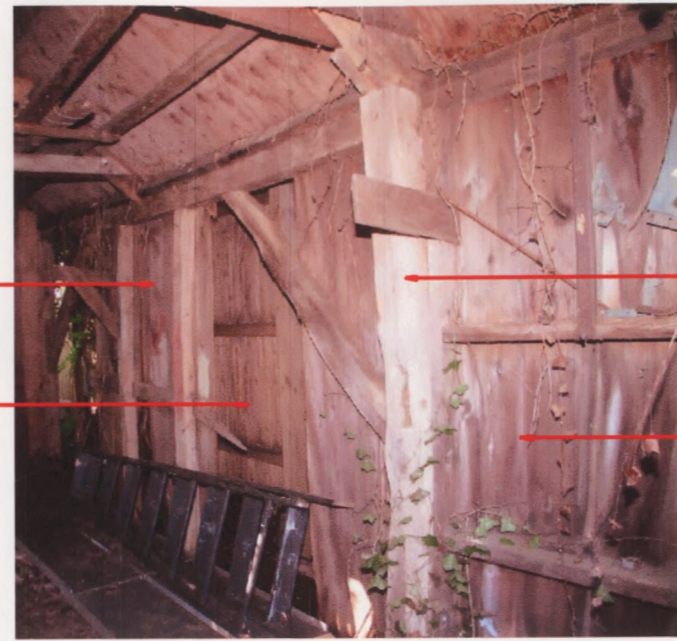
NORTH WALL FROM INTERIOR

OAK CORNER POST OF 18TH-CENTURY BUILDING

GARAGE ADDITION

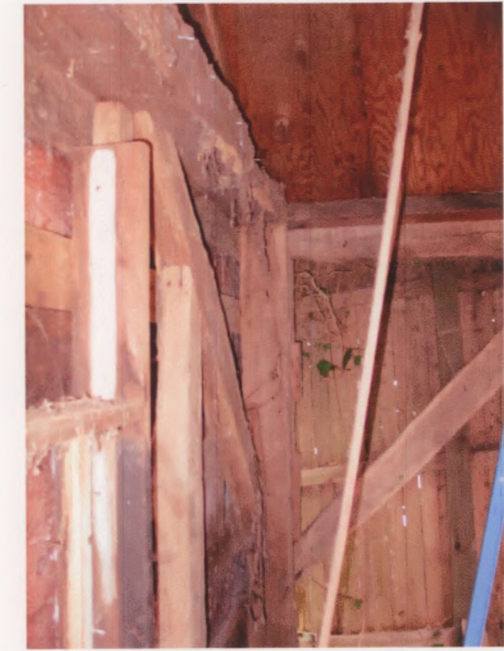
INTERIOR VIEW SHOWING HEWN OAK FRAME OF THE ORIGINAL BUILDING: THE NORTHWEST CORNER POST, SOUTH PLATE, WEST TIE BEAM AND WIND BRACES

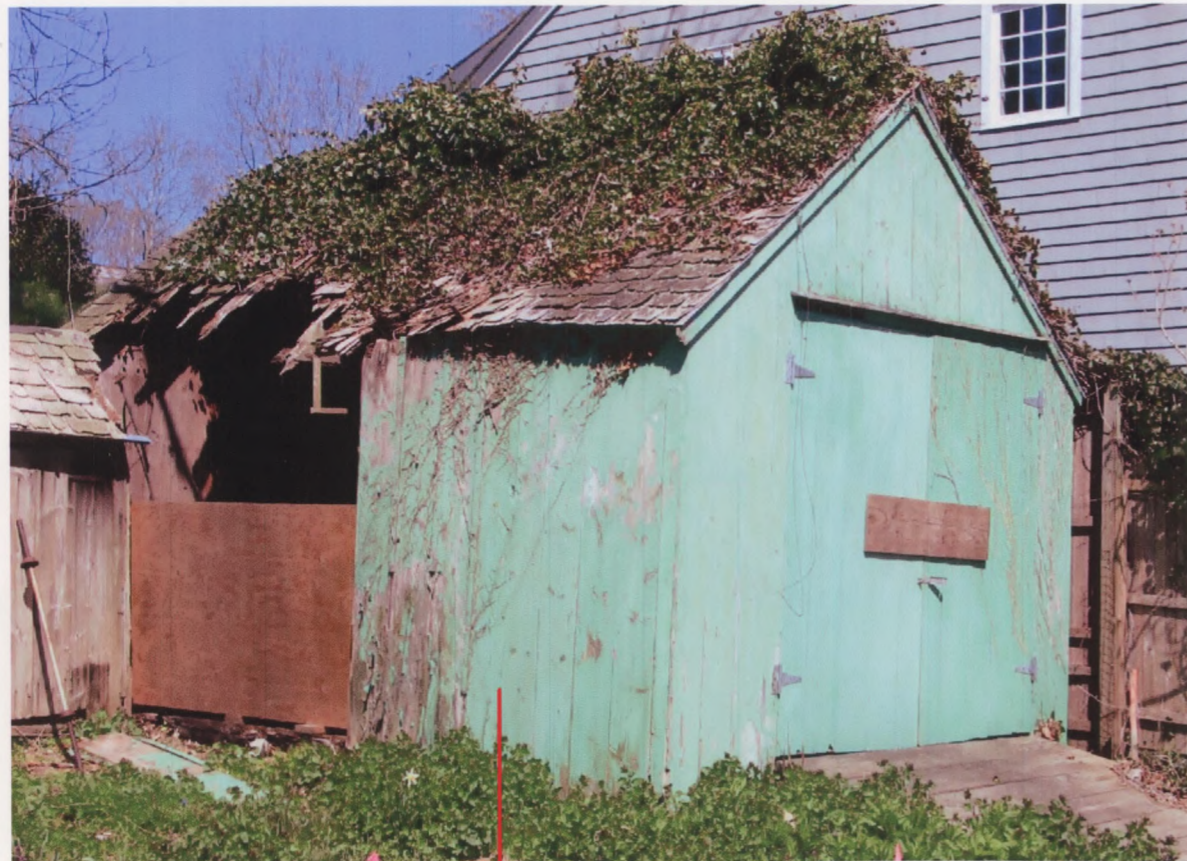
18TH-CENTURY BUILDING ← → GARAGE ADDITION

SOUTH WALL AND EAST WALL WITH GARAGE DOORS

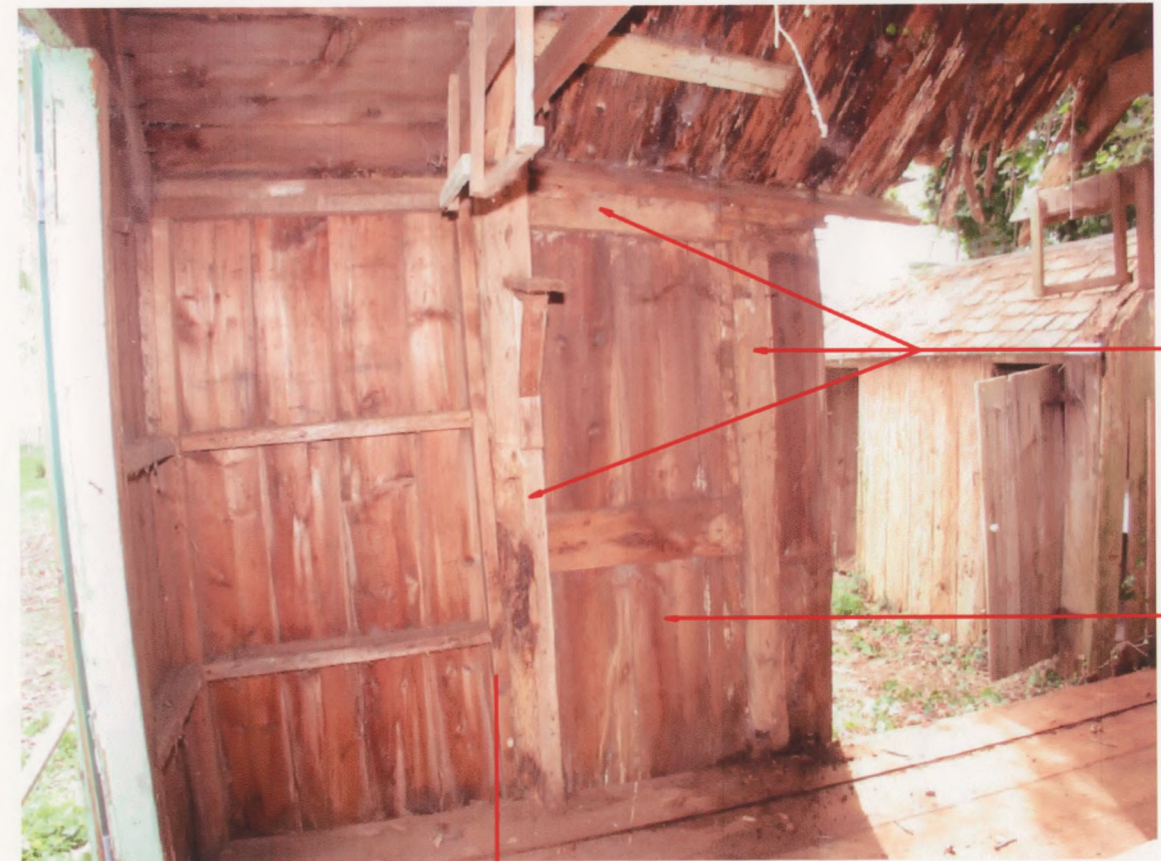
ORIGINAL OAK FRAME

19TH-CENTURY PINE VERTICAL-BOARD SIDING
